Anchorage in naturally corroded specimens taken from existing structures

ABSTRACT: In an on-going project, the anchorage capacity of naturally corroded steel reinforcement was investigated experimentally. The beam specimens were taken from edge beams of Stallbacka Bridge in Sweden. The specimens showed different extent of corrosion induced damage; from no sign of corrosion to extensive cracking and spalling of the concrete cover. After consideration of different possible test setups, a four point bending test indirectly supported with suspension hangers was chosen. The beams were strengthened with transverse reinforcement around the suspension hangers to avoid a premature failure. Eight successful tests have been carried out so far; in all these, a diagonal shear crack preceded an anchorage failure. The anchorage behaviour was examined through monitoring the applied load, free-end slip and mid-span deflection. The test results can be used to extend our knowledge concerning the structural behaviour of corroded reinforced concrete structures to field conditions.

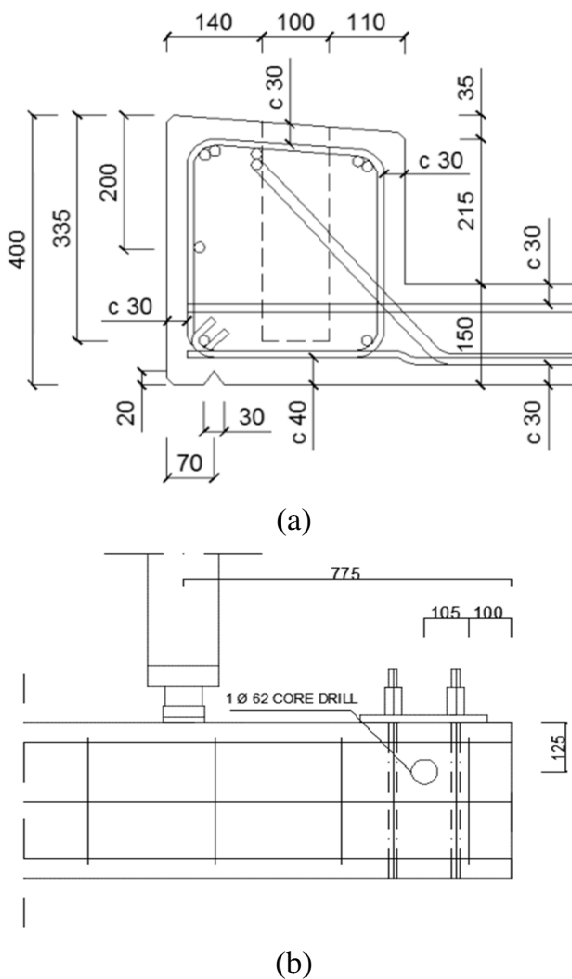
Figure 1. (a) Cross-section of the edge beams, (b) details of the test set-up and the strengthening bars.

In Figure 1(a), the geometry of the edge beams is shown. They were 350 x 400 mm in cross-section, with a small inclination of the upper surface. The longitudinal reinforcement consisted of four bars Ø16 Ks60 bundled in pairs in the upper part, and two bars Ø16 Ks60 at the bottom. The transverse reinforcement consisted of Ø10 s300 Ks40. The longitudinal reinforcement bars closest to the upper inclined surface of the edge beams were more damaged than the other longitudinal bars as they were most exposed to de-icing salt. Therefore, they were considered to be more interesting in the investigation of bond and anchorage behaviour. The edge beams show different extent of corrosion-induced damage, from no sign of corrosion to extensive cover cracking resulting in spalling of concrete cover. Based on the damage patterns; the test specimens were categorized into three different groups: Reference (R) specimens, and Medium (M) and Highly (H) damaged specimens. The edge beams were reinforced, both longitudinally and transversally, with deformed bars, i.e. ribbed bars. In Figure 2, some examples of test specimens before testing are shown.

The edge beams were strengthened with transverse reinforcement around the suspension holes to avoid premature failure of the beam at the support suspension holes. Pre-stressing steel bars of Ø20 were used for strengthening. The strengthening bars were anchored at the top of the beam with hexagonal nuts and flat steel plates, Figure 1(b). The mechanical locking of the bars, by means of threaded coupling, was considered to provide adequate anchorage to avoid failure at the suspension hole. The bars were injected with epoxy.

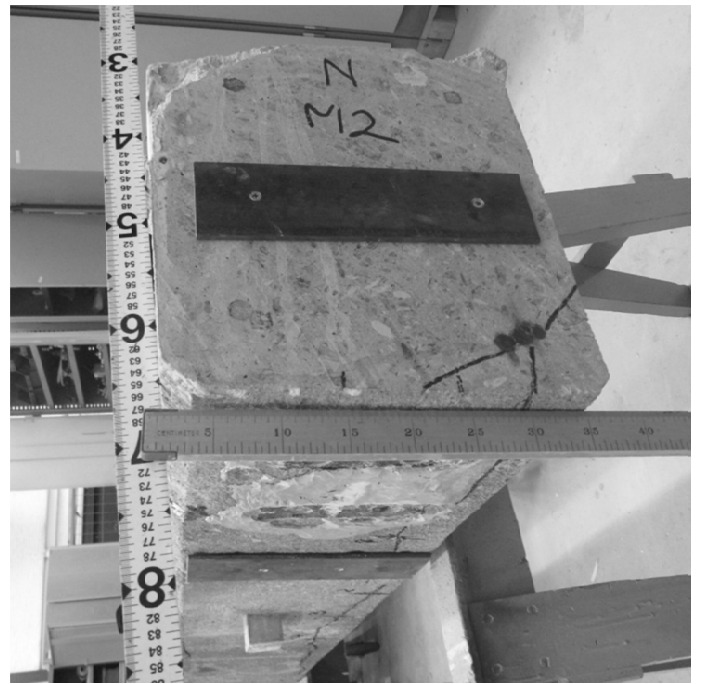
(a) Medium Damaged M2

Figure 2. Photos of some of the test specimens before testing.
